Manufactured Housing Research Alliance

Improving Air Distribution System (ADS) Performance in Manufactured Homes

**Final Report to HUD for Cooperative Agreement
Contract Number H-21353CA**

January 2, 2003

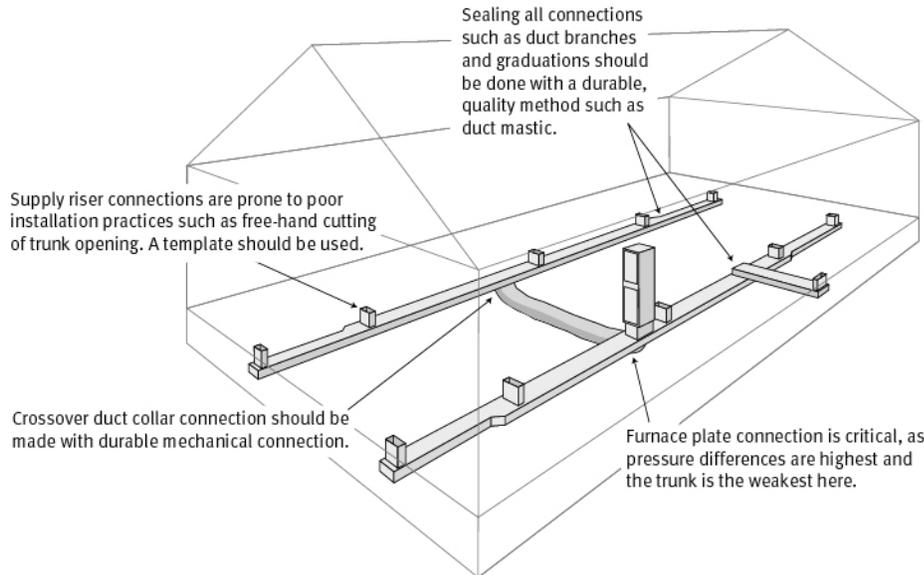
Figure 2. Typical ADS system recommendations

Patching was rarely suggested as a primary improvement method. Only in the case where the trunk was not aligned with the furnace was a patching method offered as a leakage solution.

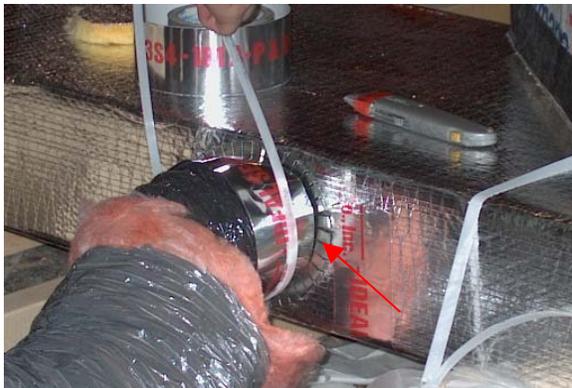
It is difficult to create a durable seal using tape or mastic alone.

The tape will support the duct during construction in the plant and the mastic will eventually cure to form a strong, durable seal. However, curing of the mastic could take several days depending on temperature and humidity conditions.

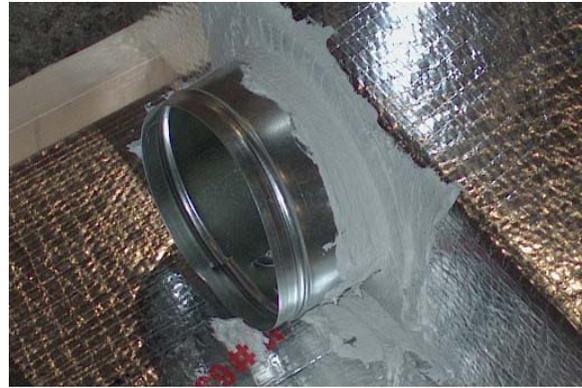
Applying tape as a temporary seal then covering the seam and tape with mastic will result in a superior and durable seal.

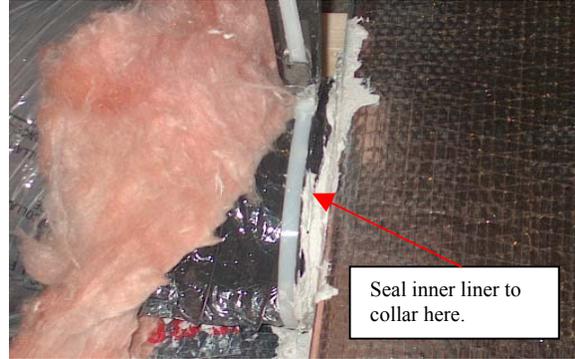
2. **Secure and seal the flex duct to the side-mount collars.** The inner liner of the flex duct should be fastened and sealed. Tape may work in this location if a plastic strap is used over it; otherwise mastic makes a good seal here as well. The inner liner should first be placed on the collar and attached with a plastic strap to hold the liner in place.

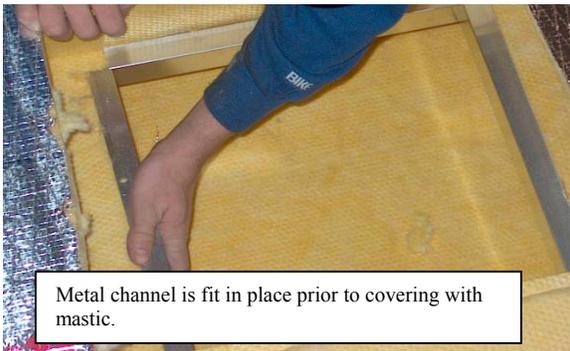
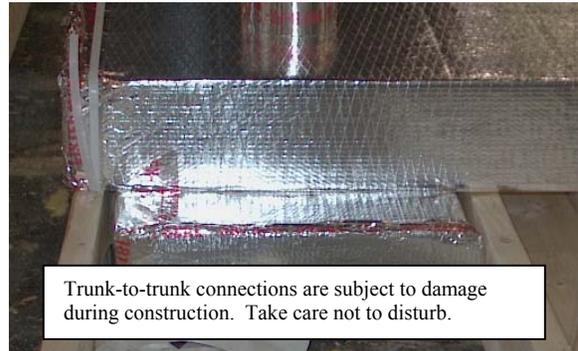
3. **Use care and attention to detail in crossover branch connections.** This is a critical area for leak prevention. Apply a good quantity of mastic between the mating surfaces of each trunk. Accurately cut the holes and use the metallic channel material shown to serve as a mechanical attachment. This material should be sealed with mastic along all exposed edges. Strap the two trunks securely to prevent any movement of the duct until the applied mastic has had sufficient time to cure. Installers should be made aware that the mating surfaces are relatively fragile and may open if any pressure is applied to either trunk prior to curing.

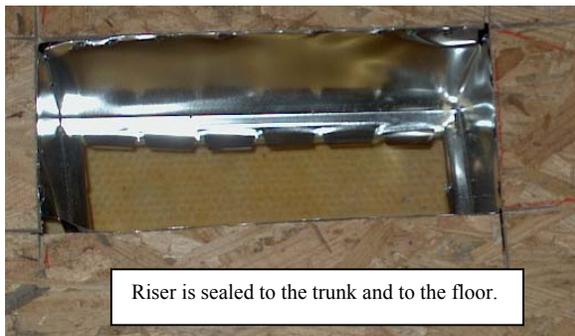
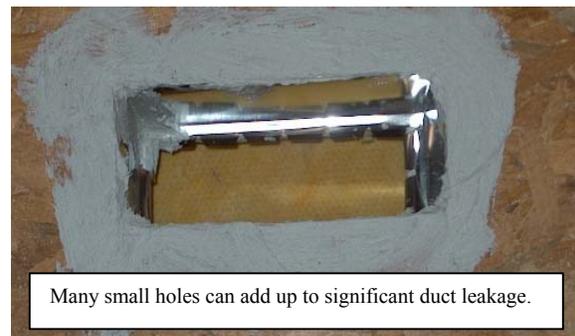
4. **Seal in-line boots to the trunk and to the floor.** Apply mastic to in-line risers prior to installation with a caulk gun. Steps are: Cut a properly sized hole into the trunk, apply mastic, install riser, and fold up tabs to complete the sealing. Other risers are available that are easier to seal (less prone to being messy).

All openings between the boot and the floor should be sealed. These small holes can add up to significant leakage.

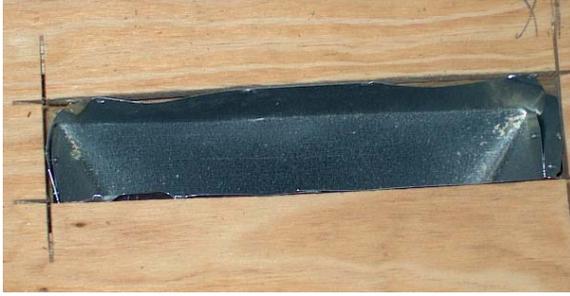
Perimeter supplies need to be sealed to the floor to prevent leakage into the belly.

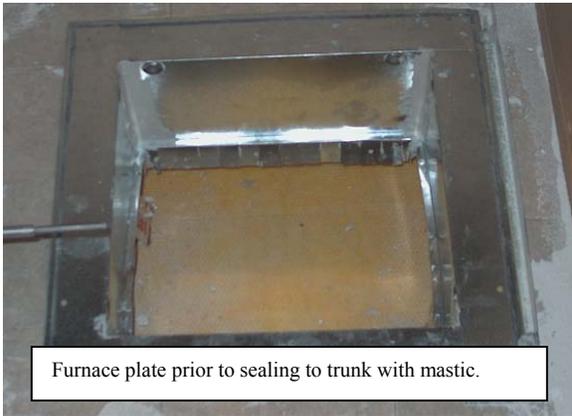
Furnace plate prior to sealing to trunk with mastic.

Other manufacturers are having success using liberal amounts of mastic applied by gloved hand to the folded finger tabs of the existing furnace plate.

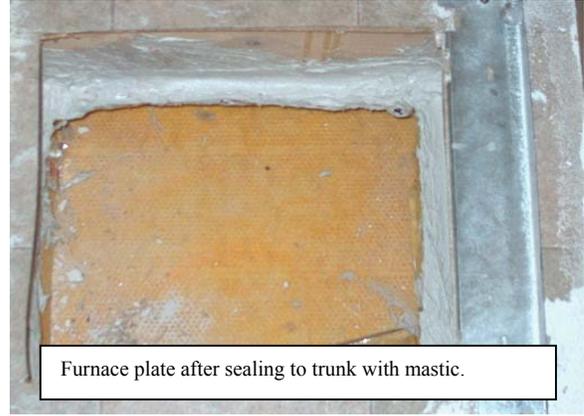
Furnace plate after sealing to trunk with mastic.

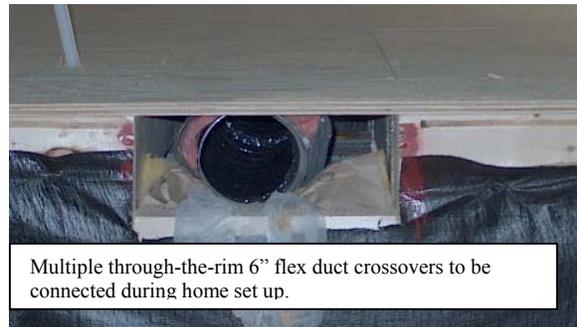
Multiple through-the-rim 6" flex duct crossovers to be connected during home set up.

6. **Use care and attention to detail in the crossover connection termination at the rim joist.** At the plant, the crossover is accomplished by extending a 6" flex connector through the marriage wall band joist in multiple locations. The connection between opposite halves of the home is done by the installer. This design leaves the essential duct sealing task to the installation crew. A faulty connection will directly impact ASD leakage.

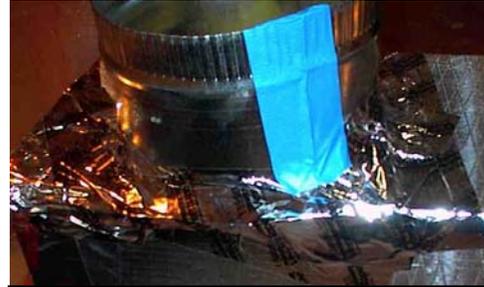
Smoke is seen leaking under the collar flange.

Round collars completely sealed with tape (above) or mastic (below) show no leakage.

1. **Seal start collars to trunk.** Start collars are known to leak, especially when freehand cut “round” holes are used. Use mastic or 100% tape coverage to seal start collars to the fiberboard.
2. **Seal flex duct to metal collars and boots with tape.** Straps alone will not seal flex duct to metal. Use appropriate tape to make this seal. Use tape and straps in conjunction with the multiple crossover connections.

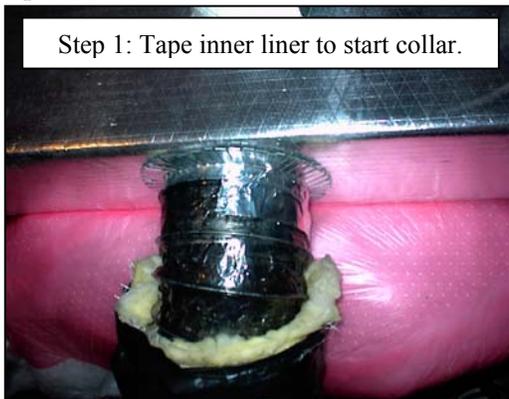
Step 1: Tape inner liner to start collar.

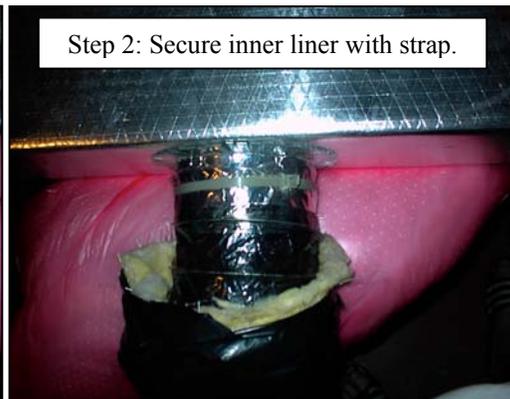
Step 2: Secure inner liner with strap.

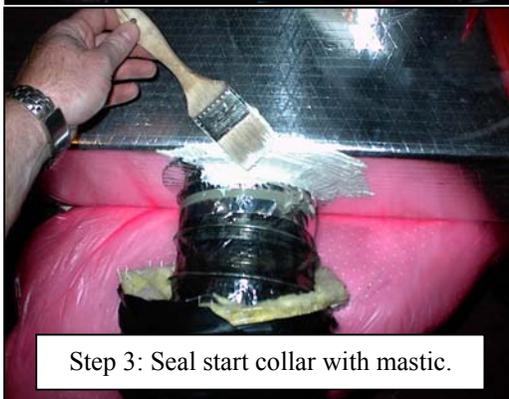
Step 3: Seal start collar with mastic.

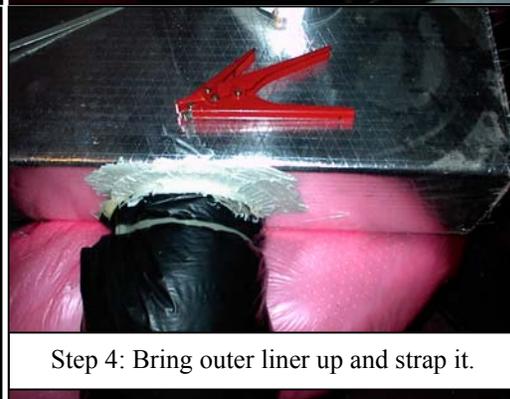
Step 4: Bring outer liner up and strap it.

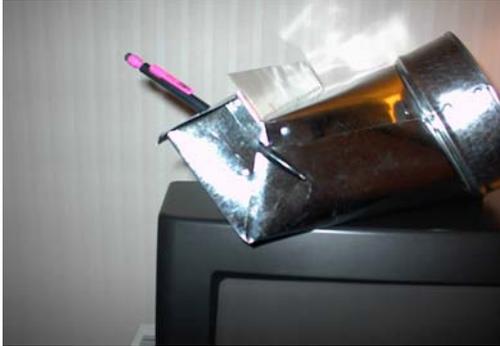
3. **Seal boots with mastic.** Supply boots have gaps that will leak conditioned air into the floor system, which in turn can leak to the outside. Because there are six or more in each section, this can add up to significant leakage. Cover all the seams completely with tape or brushed-on mastic.

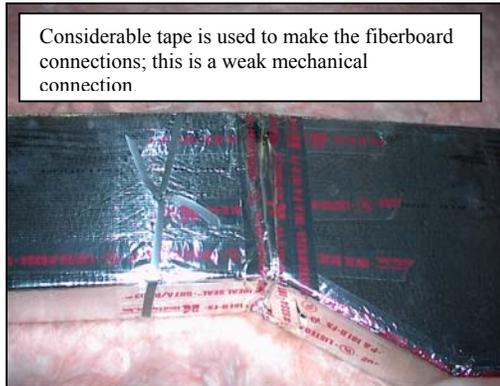
4. **Use a squeegee tool on taped joints in fiberboard ducts.** Moderate stress is applied to the trunk when it is moved from the overhead station where it is assembled to the floor below. Be sure taped seams are properly squeegeed to ensure maximum adhesion strength. Take care not to break any seams when moving and installing this duct into the floor.

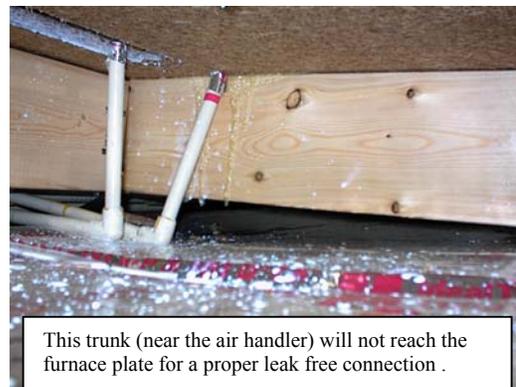
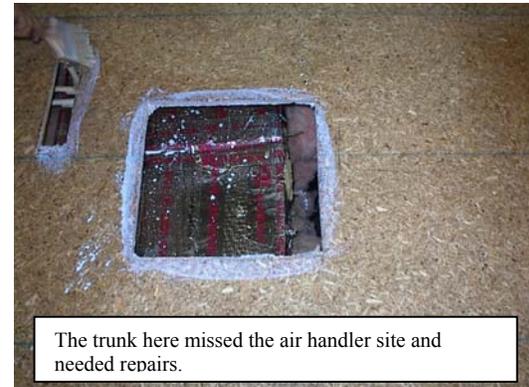
5. **Positioning of the trunk is important for a proper seal with the air handler.** The furnace plate connection is the most important connection to seal. In several homes the trunk was not secured snugly to the floor joists resulting in a gap between the trunk opening and the furnace plate. Also, trunks were found that were not aligned exactly under the air handler. These are difficult repairs to make leak free. To minimize these incidents, develop an engineered plan for these situations rather than having the production staff make one up on the fly.

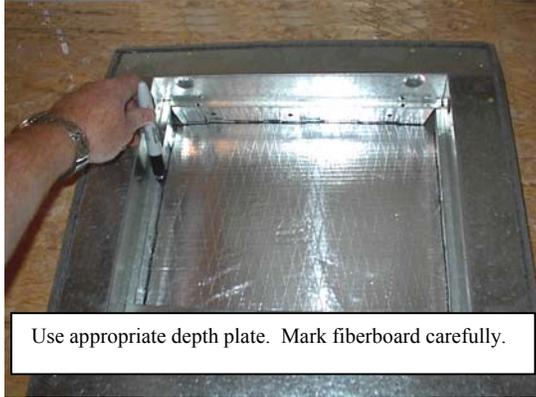
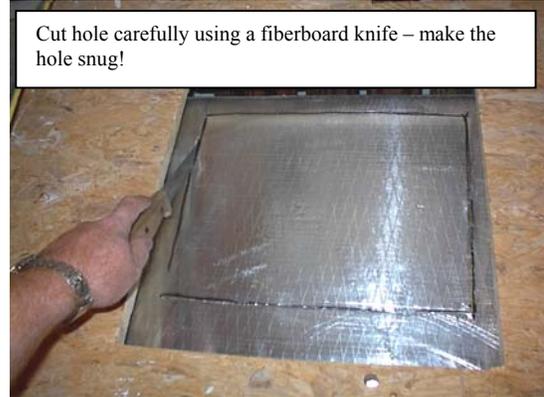
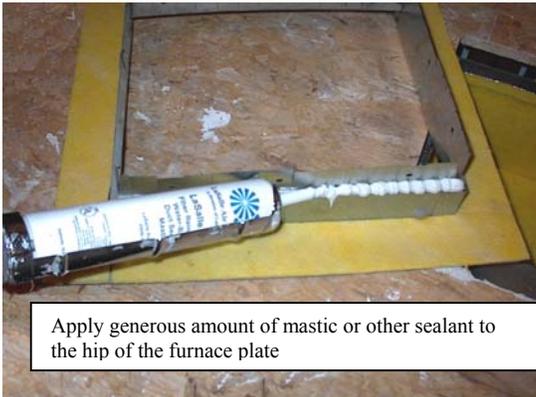
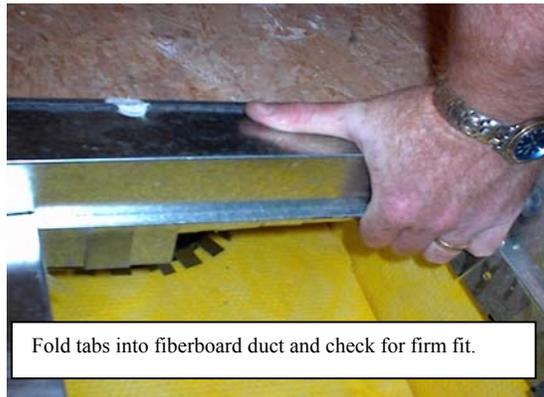
6. **Properly fasten and seal the air handler plate to the duct board.** This requires carefully marking the duct board using the furnace plate as a guide and carefully cutting the hole into the trunk. The manufacturer recommends using a duct board knife to make this cut. This hole should not be oversized; there is only 1/4" of lip available for sealing to the duct board. Tape will not seal the plate to duct board. Use mastic as shown.

Additional mastic can be used to fill any remaining gaps in this connection. Mastic should not be used as a substitute for a poorly made cut. Mastic will not provide structural support – only air sealing. Mastic should be allowed to fully cure before use.

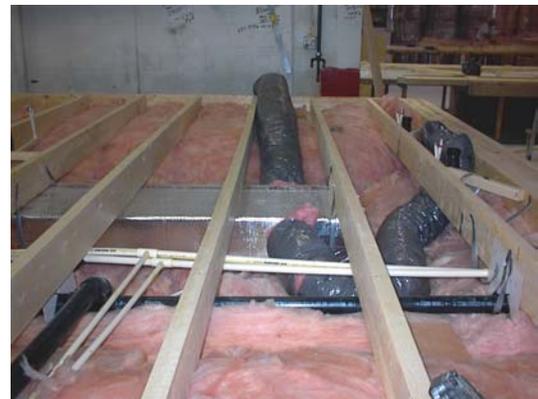
7. **For improved airflow, minimize excess length and curves in the flexible duct sections.**

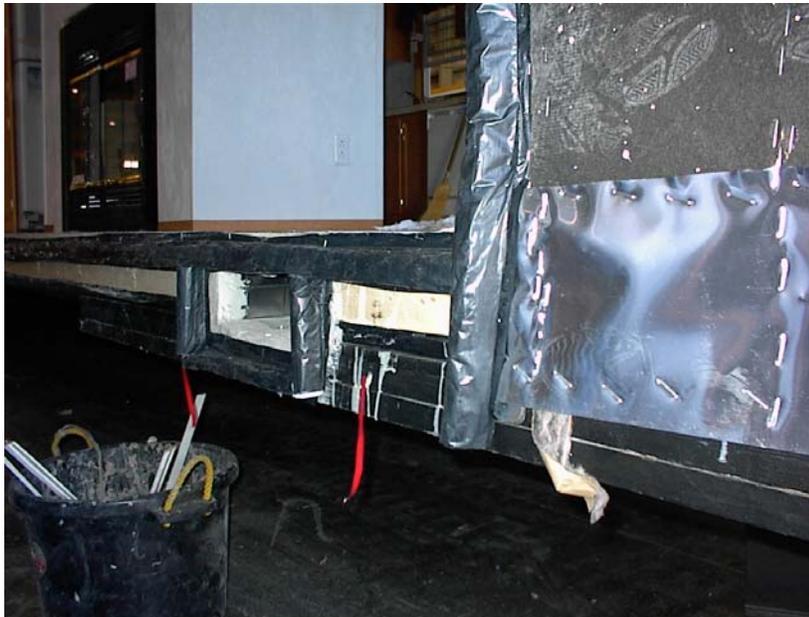
Below is an interior view of the marriage wall which shows the plant-installed marriage line gasket and the through-the-rim crossover duct.

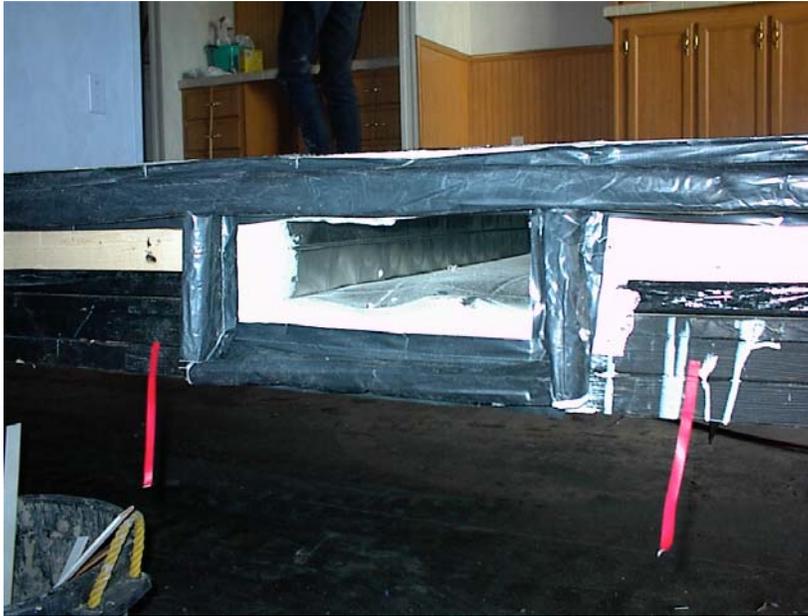
Close up of crossover configuration. Note the use of mastic to air seal the trunk prior to the application of the gasket.

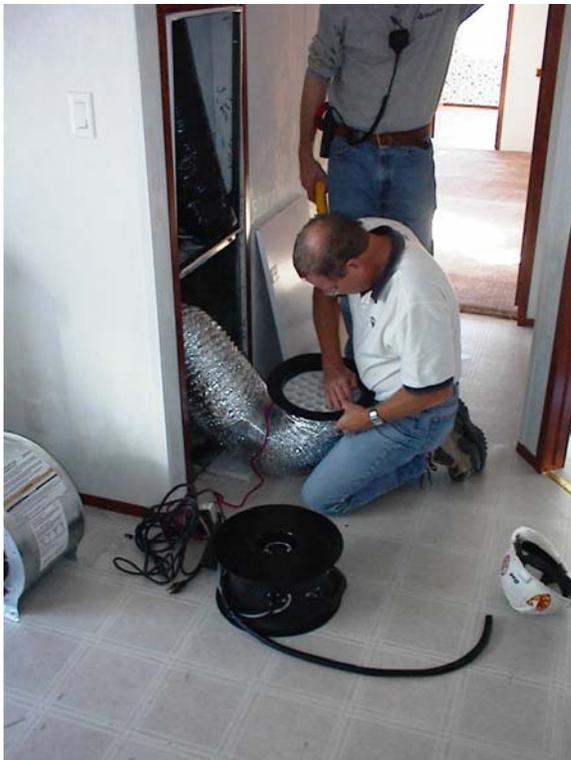
DAPIA installing calibrated duct fan at the preferred location to measure duct leakage. Removing the blower and measuring close to the ducts minimizes measurement errors.

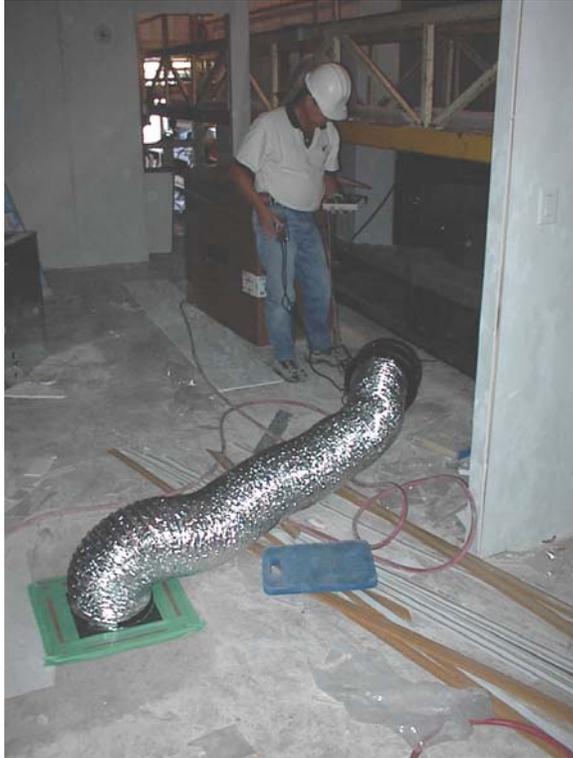
DAPIA installing calibrated fan at a supply to measure duct leakage in a floor section that is without a furnace. Although this is a less preferred location to access the ducts, with the small leakage levels experienced, any error is negligible.

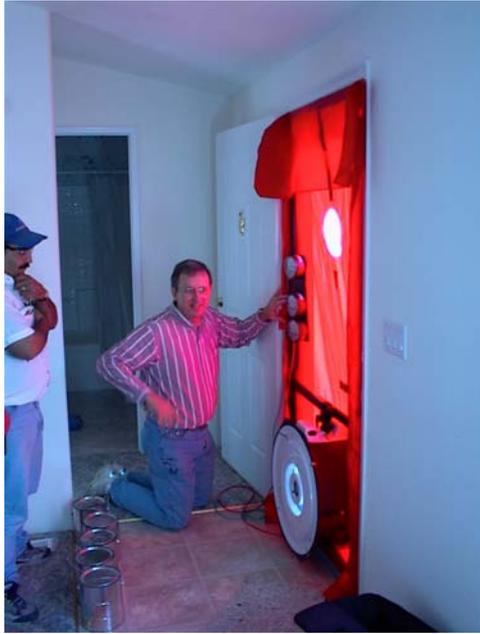
Blower door testing being conducted in a single section home outside the plant.

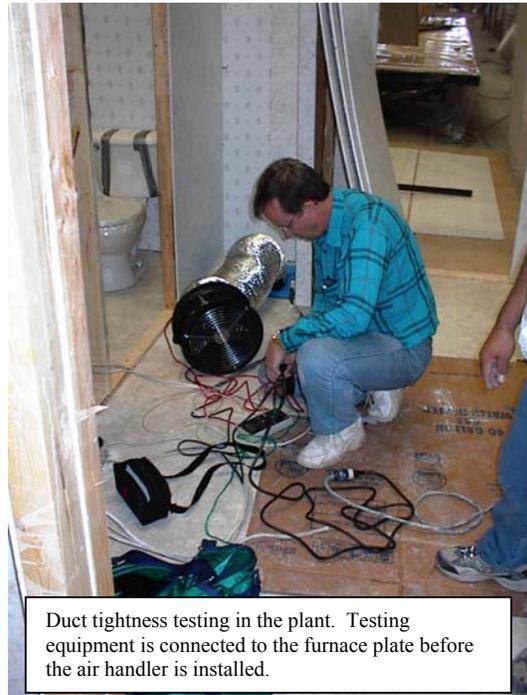
Duct tightness testing in the plant. This home section has no air handler unit so testing equipment is connected to a supply opening.

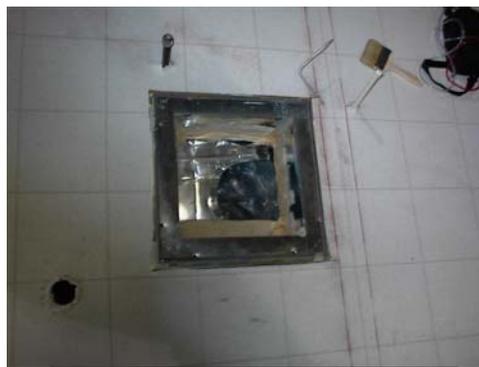
Training plant personnel on the proper application of mastic to the duct system.

Furnace plate sealed with mastic.

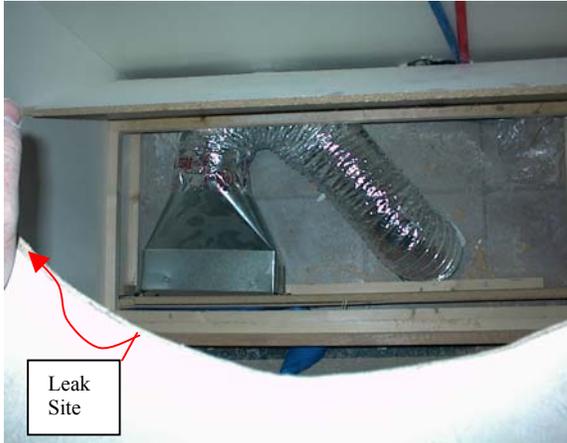
This is a view looking down through a bathroom sink cabinet to the toe-kick supply. This supply was not mounted flush to the cabinet and the cabinet fascia was cracked. By sealing this supply 14 cfm was added to the total duct leakage measurement. In theory this leak would all be eliminated under leakage to the outside test. To fix the problem, screws were used to mechanically fasten the connection and the duct test was repeated.

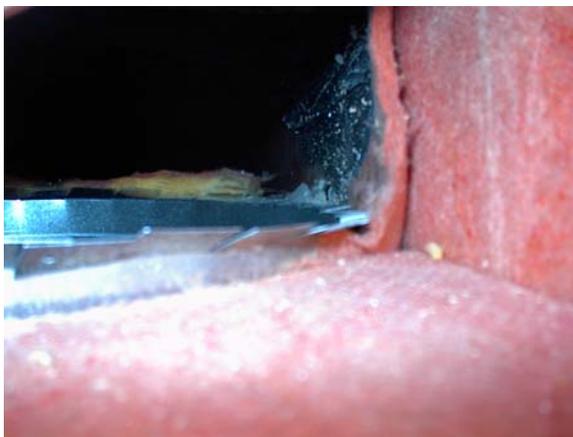
Low clearance under the homes in the plant limited the access to the underside of the homes. The status of the belly and crossover collar cannot be confirmed until the end of the construction process when the home is lifted onto axles.

A partial repair of the crossover collar may be the source of unresolved leakage in this duct. Prior to being relocated, the collar was located over a metal stabilizing bar welded to the frame.

⁵ Higher than normal duct system leakage in home #6 was unresolved. However it is obvious from inspection that the crossover flex collar was originally located over a stabilizing bar of the frame and subsequently had been moved. It is likely that either the movement of the flex collar caused some leakage or that when the home was flipped, the fiberboard duct trunk system was partially crushed. Such damage has been observed at other manufacturers employing a similar process.

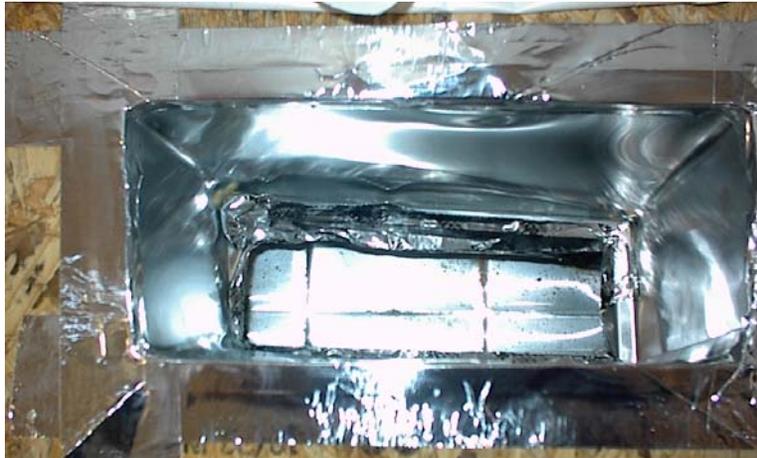
In-line supply connector showing tape at trunk connection. Cutting a properly sized hole and applying mastic to the connector prior to insertion into the floor is the preferred method of insuring a good seal.

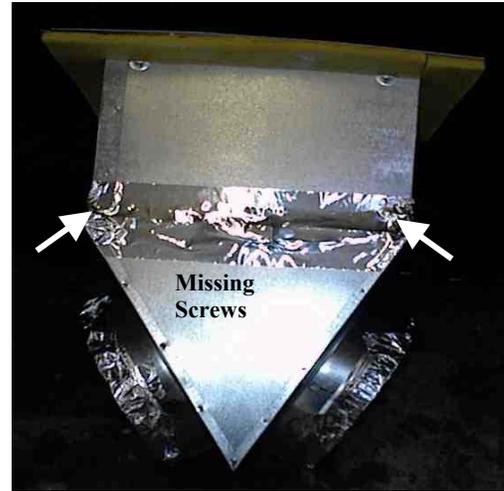
1. The metal “crossover duct splitter box” was not mechanically secured to the “furnace connector boot” in three of four inspected homes. This critical connection was held together with only one layer of foil tape. The crossover duct splitter box could become disconnected from the furnace connector boot due to the weight of the splitter box and crossover duct.. The crossover duct splitter box and furnace connector boot were pre-assembled off line and should have been secured with 4 screws when the furnace was installed. To avoid this oversight, these screws should be installed off line when these duct pieces are first assembled.

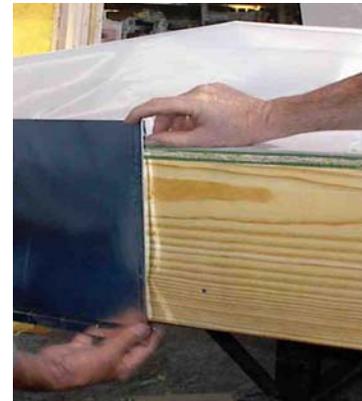
2. The in-line supply register risers have several shortcomings: The very narrow profile of the connector (less than 3”) leaves insufficient room for the hand and arm to reach in, cut the rectangular opening in the supply trunk, install the riser and tape the joint. Installed through the subfloor, these connectors take considerable time to install. Installation of two risers took two men approximately 30 minutes. The resulting connections have four times as much air leakage compared to the perimeter connectors.

Twelve-inch long connectors being used are too tall for use with the 10” floor joists. The boots extended into the supply trunk blocking airflow and causing duct leakage. As installed, the in-line ducts inspected will significantly restrict supply airflow. Furthermore, the supply riser is not made square to the supply trunk, and in several instances scrap metal cut from the supply trunk was found still partially attached to the trunk further restricting airflow.

One solution to these problems is to install wider (4-inch) in-line boots. Another option is to convert the in-line boots to short perimeter type flex duct connections. Investigate using a zip spiral saw for a better method to cut the trunk for the in-line supplies.

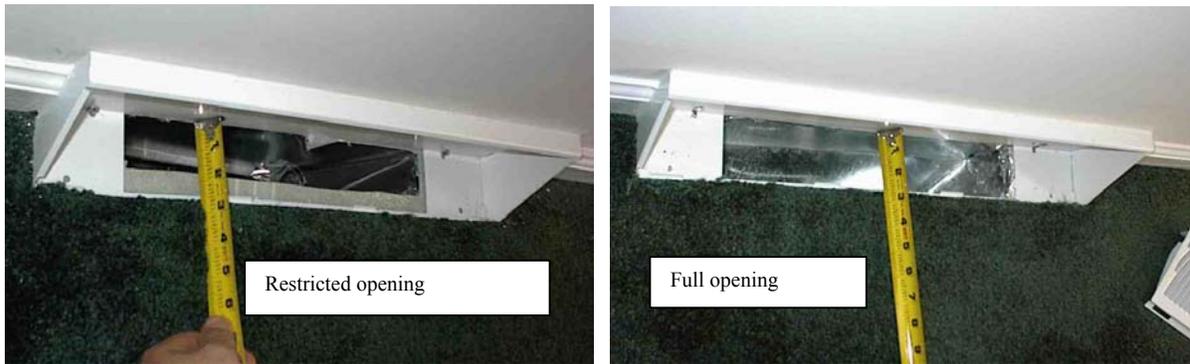
The supply register discharge opening in the floor was often partially blocked by interior walls that overlapped the hole or by poorly cut vinyl flooring.

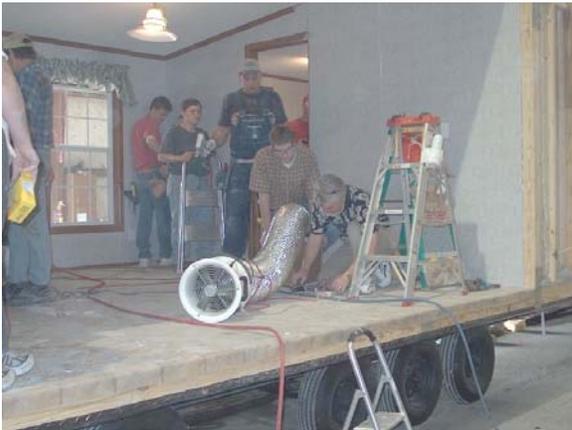
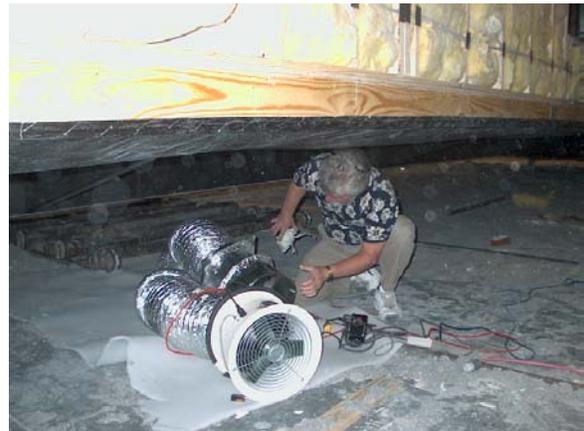
Testing total duct leakage in-the-plant through available openings into the ducts: a supply termination on the floor decking (left) and the crossover collar underneath the home (right) can be used to measure low flows with little loss in accuracy. Total duct leakage can be used to estimate leakage to the outside when the home is set up.

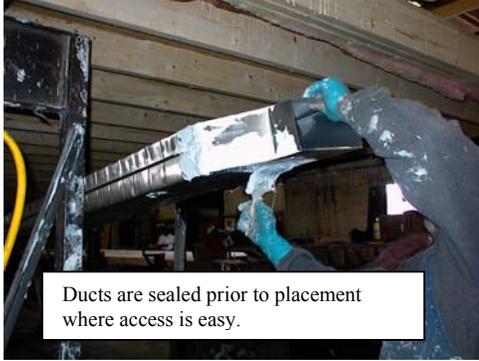
Ducts are sealed prior to placement where access is easy.

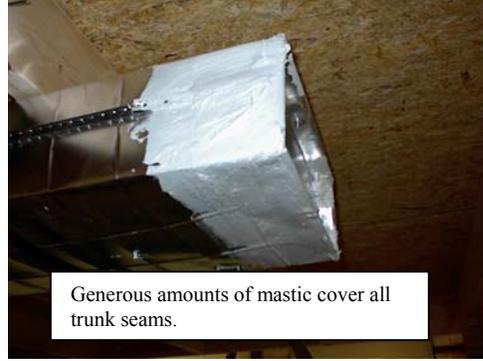
Generous amounts of mastic cover all trunk seams.

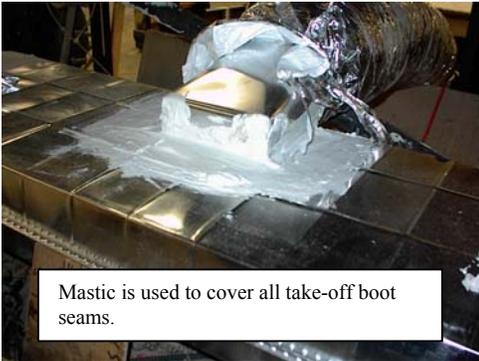
Mastic is used to cover all take-off boot seams.

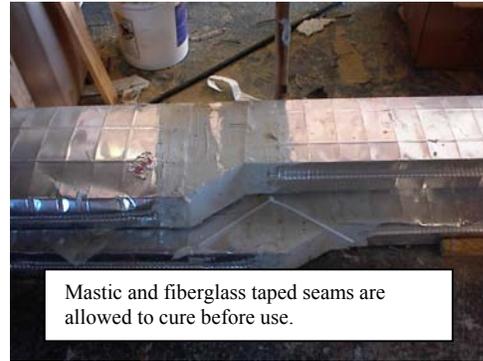
Mastic and fiberglass taped seams are allowed to cure before use.

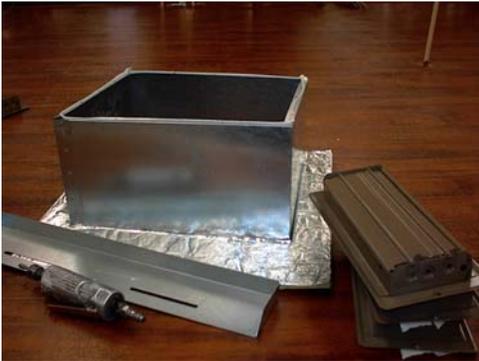
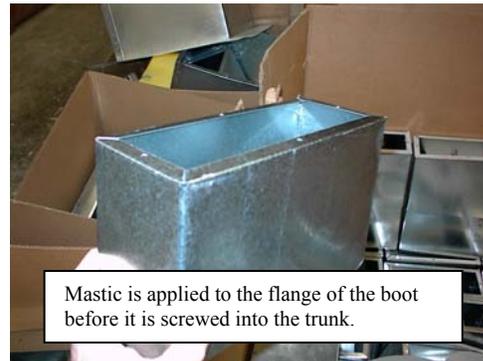
- 2. Maintain furnace plate and duct riser seal.** The furnace plate connection is arguably the most important connection to seal. The plant uses a “caulk and screw down” design for both the furnace plate connection and the straight risers. The trunk is not opened until after the connections are secure – resulting in a perfectly aligned hole.

Mastic is applied to the flange of the boot before it is screwed into the trunk.

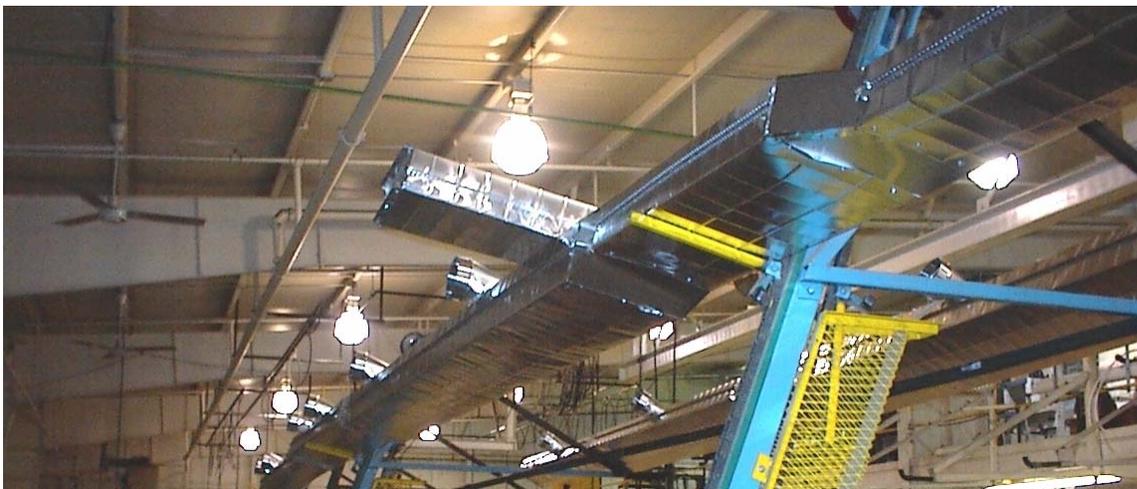
1. Trunk assembly

The plant pre-builds most of their duct systems and stores them on a rack prior to insertion into the floor system. A smoke test at this point revealed that several of the connections leaked – particularly the duct graduation connectors and the branch sections – even though the plant is already using a curable sealant on the connections. This is an ideal application for brushed-on mastic to provide superior sealing of the metal duct system. A more thorough application, using a brush, for critical connectors using the current sealant material should result in similar improvement.

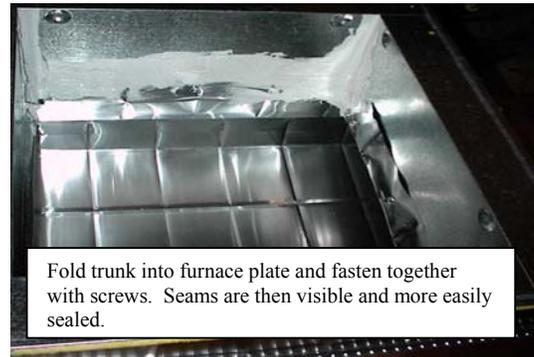
Figure 5.4 Furnace Boot Connections

The following are alternative recommendations for leak free furnace plate assembly: MHRA recommends making a “picture frame cut” into the trunk and screwing it into the side of the furnace base, and sealing with mastic. This is a superior performing and more durable connection. (See Figure 5.4 from MHRA publication *Duct Systems: Guide to Best Practices* for a good illustration.)

There is often little tolerance for locating the furnace base over the trunk. This is the worst leak site in the duct system. MHRA recommends making a “picture frame cut” into the trunk, screwing it into the furnace base and sealing with mastic. This will result in a more airtight and durable connection. (See the MHRA publication *Duct Systems: Guide to best practices* Figure 5.4 for a good illustration.) The furnace manufacturer should review this recommendation.

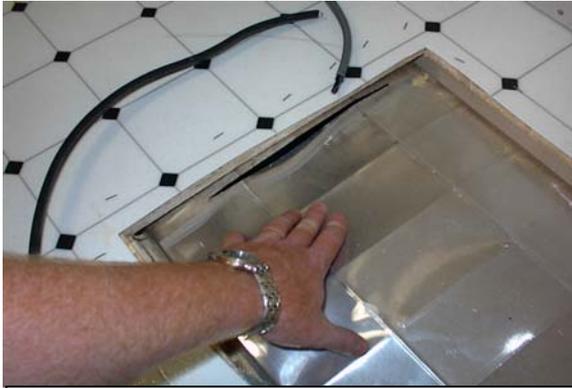
Branch ducts have zero clearance for saw cut through floor sheathing; the picture frame cut cannot be used.

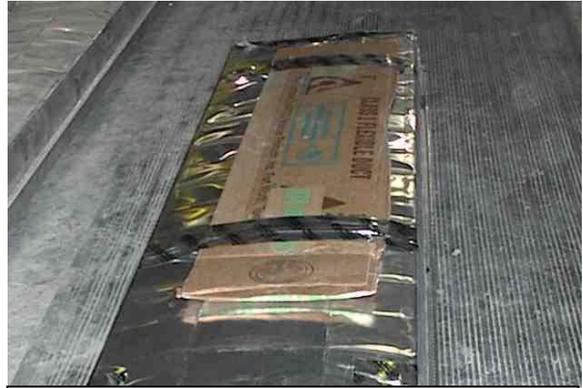
Cardboard spacer provides clearance for later saw cut through floor sheathing.

When the furnace is located over a branch duct, cutting through the floor sheathing can result in cutting through the duct, thus preventing the picture-frame-cut fastening method. A cardboard spacer installed earlier in the process will prevent accidental cut-through.

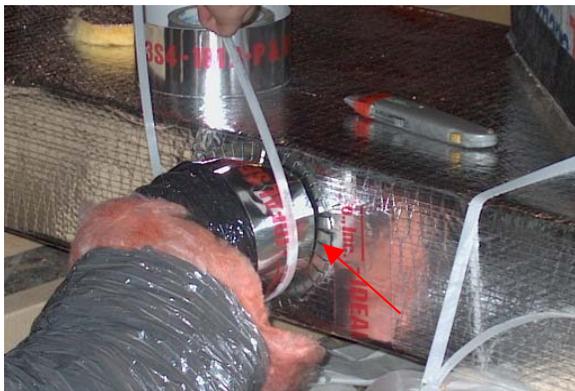
- 1. Seal side mounted collars.** Fiberboard systems rely on tabs folded into the duct for mechanical fastening. These tabs are less rigid than screw-type fastenings and increase the difficulty in sealing. Tapes designed for metal to fiberboard attachment may be used for sealing the collars and some manufacturers have had good success with this method. The other method (practiced at this plant) is to apply enough tape to secure the collar at the top and bottom and to apply a liberal layer of mastic completely covering the tape. The tape will support the duct during construction in the plant and the mastic will eventually cure to form a durable strong seal. However, mastic curing could take several days depending on temperature and humidity conditions.

It is difficult to create a durable seal using tape or mastic alone.

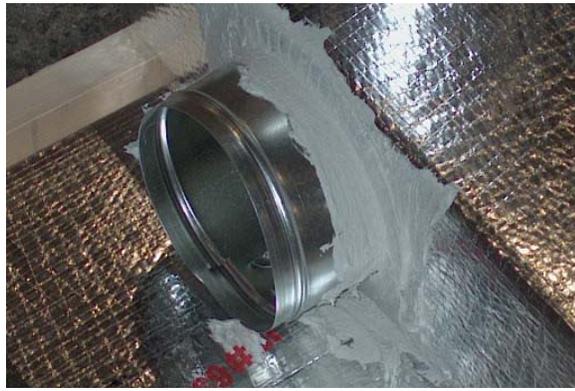
Applying tape as a temporary seal then covering the seam and tape with mastic will result in a superior and durable seal.

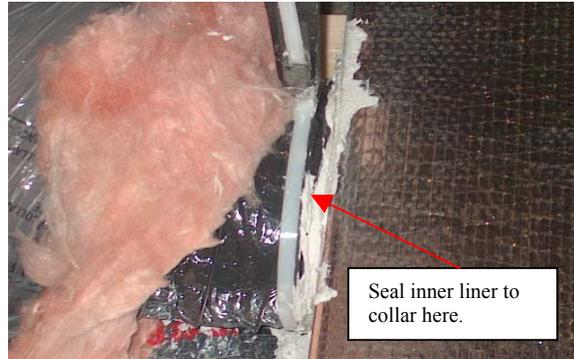
2. **Secure and seal the flex duct to the side-mount collars.** The inner liner of the flex duct should be fastened and sealed. Tape may work in this location if a plastic strap is used over it; otherwise mastic makes a good seal here. The inner liner should first be placed on the collar and attached with a plastic strap to hold the liner in place.

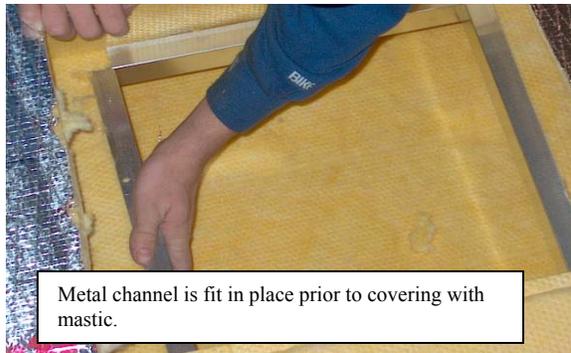
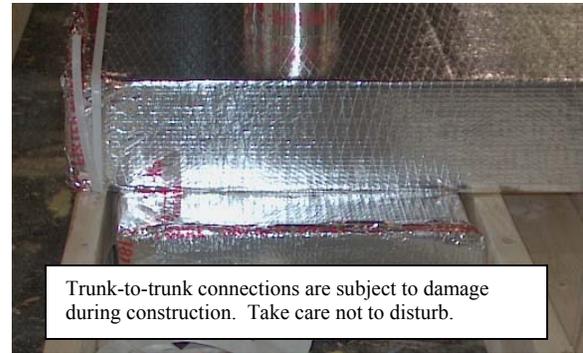
3. **Use care and attention to detail in crossover branch connections.** This is a critical area for leak prevention. Apply a good quantity of mastic between the mating surfaces of each trunk. Accurately cut the holes and use metallic channel to serve as a mechanical attachment. The channel should be sealed with mastic along all exposed edges. Strap the two trunks securely to prevent any movement of the duct until the mastic has had sufficient time to cure. Installers should be made aware that the mating surfaces are relatively fragile and may open if any pressure is applied to either trunk prior to curing.

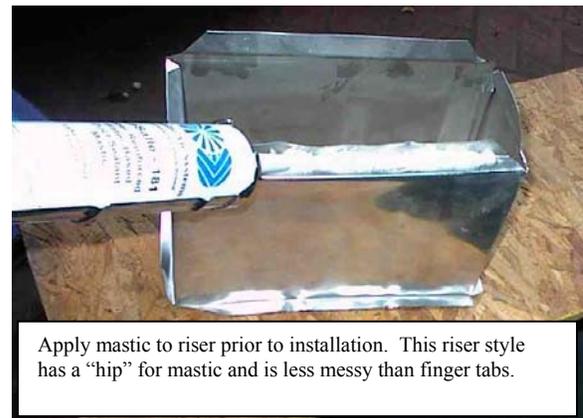
4. **Seal in-line boots to the trunk and to the floor.** Apply mastic to in-line risers prior to installation with a caulk gun. Steps are as follows: cut a properly sized hole into the trunk, apply mastic, install riser, and fold up tabs to complete the sealing. Other risers are available that are easier to seal and less prone to being messy.

All openings between the boot and the floor should be sealed. These small holes can add up to significant duct leakage.

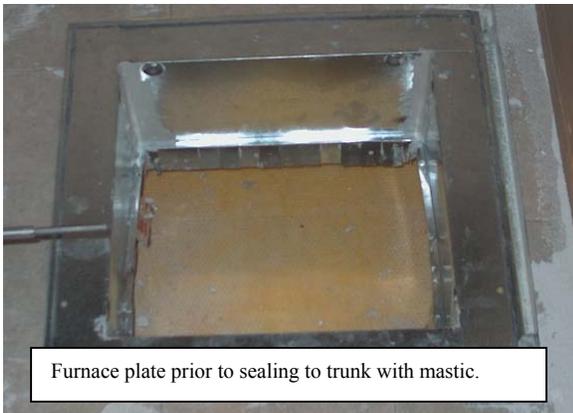
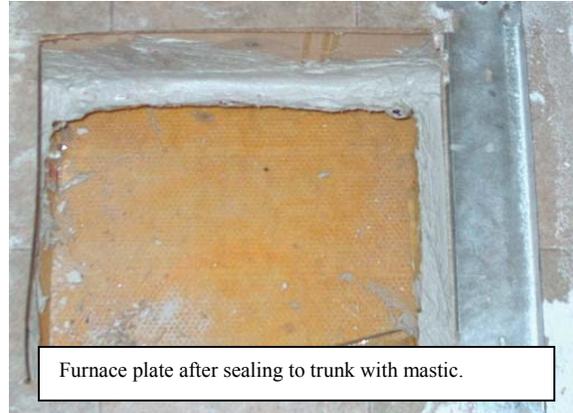
5. **Redesign the furnace plate/plenum to the duct board connection.** The furnace connection is often the leakiest site in the duct system. One option is to manufacture a metal channel designed to attach the inside of the duct board material and the plenum sidewall. The channel should be secured with screws and sealed with mastic.

Other manufacturers are having success using liberal amounts of mastic applied by gloved hand to the folded finger tabs of the existing furnace plate.

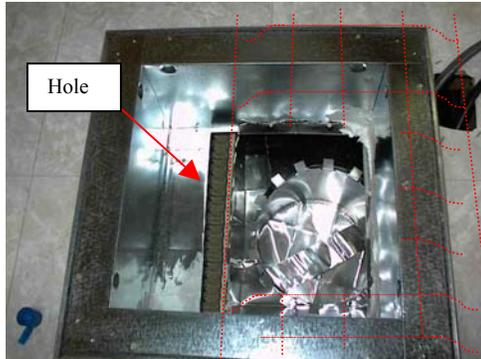
Hole left due to misalignment of trunk with furnace base.

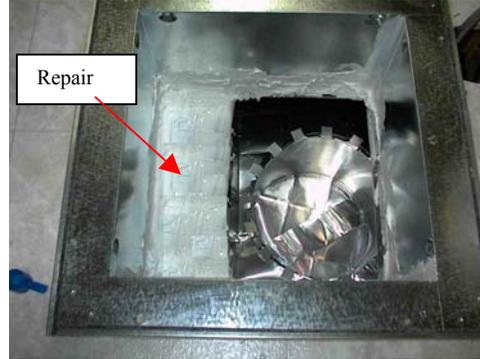
Hole repaired with scrap metal, screws and mastic.

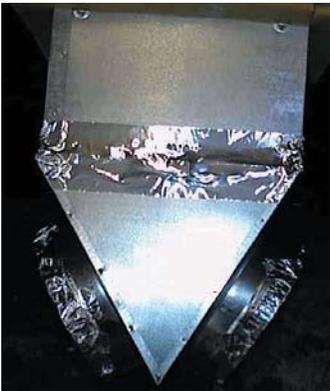
<ul style="list-style-type: none"> • Metal crossover duct splitter box is not mechanically secured to furnace connector boot in three of four homes—critical connection held together with one layer of foil tape. This can lead to disconnections of the crossover duct splitter boxes. 	<ul style="list-style-type: none"> • The crossover duct splitter box and furnace connector boot were pre-assembled off-line and should have been secured with 4 screws. Install screws offline when duct pieces are first assembled.
	<ul style="list-style-type: none"> • Connector for in-line supply register riser has very narrow profile (less than 3”), making installation through subfloor time-consuming. 	<ul style="list-style-type: none"> • Install wider (4”) in-line boots or convert the in-line boots to short perimeter type flex duct connections.

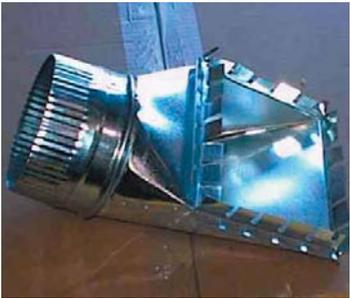
<ul style="list-style-type: none"> • Furnace connection box and rectangular-to-round flex duct takeoffs have numerous tabs that are bent over to mechanically fasten these joints. This is time-consuming and involves many sharp edges and unnecessary leakage sites. 	<ul style="list-style-type: none"> • Redesign box without tabs or use a single bendable flange instead of hard-to-seal tabs; redesign takeoffs with wider or single flaps.
